## Safety Compliant Breakaway Pole Base

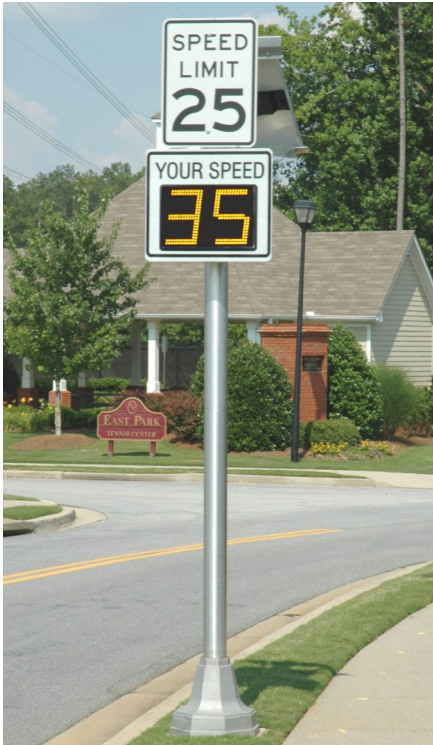
1.) Radarsign driver feedback sign in East Park subdivision in Marietta, GA prior to impact by a hit and run driver.

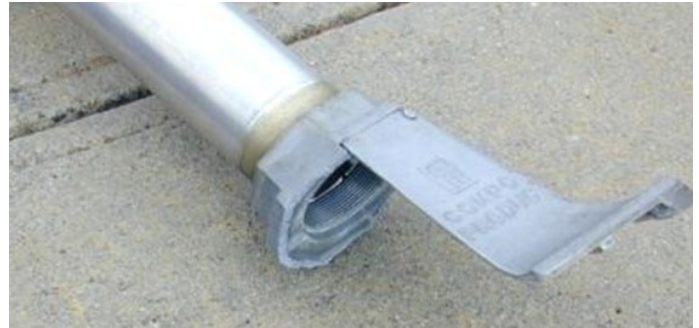
3.) Radarsign's pole base broke away from the sign pole on impact as it was designed to do.

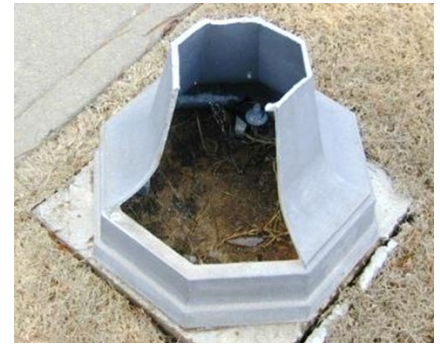
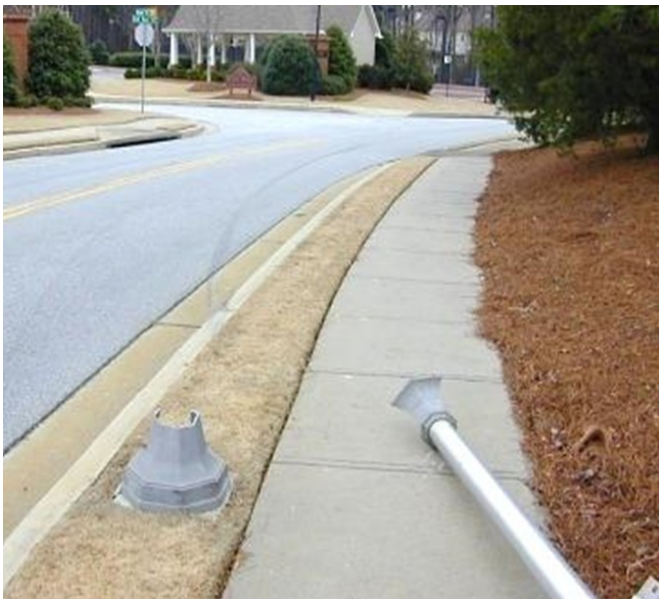
2.) The City of Marietta Police investigated the incident. It was estimated that the vehicle was traveling approximately 40-50MPH in a 25 MPH zone when it crossed lanes and struck the radar speed sign.

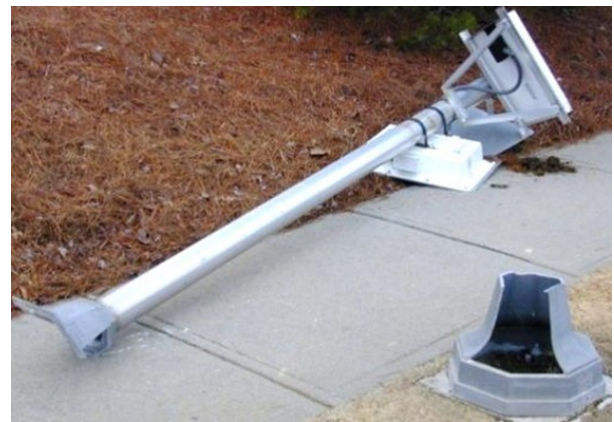
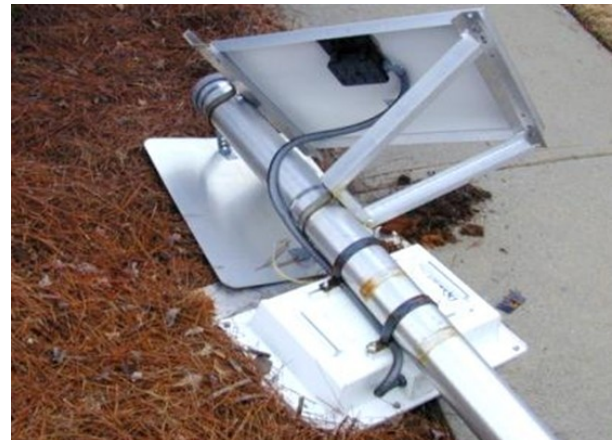
4.) The radar speed sign sustained minimal cosmetic damage to the YOUR SPEED faceplate. The radar speed sign and solar panel remained operational and intact.
