## Radarsign's Safety Compliant Breakaway Pole Base

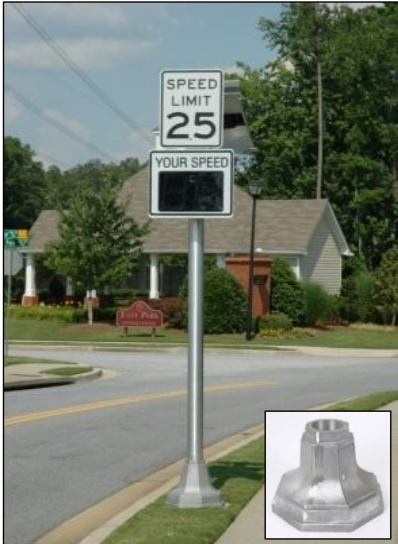
Radarsign in East Park subdivision in Marietta, GA prior to impact by a hit and run driver.

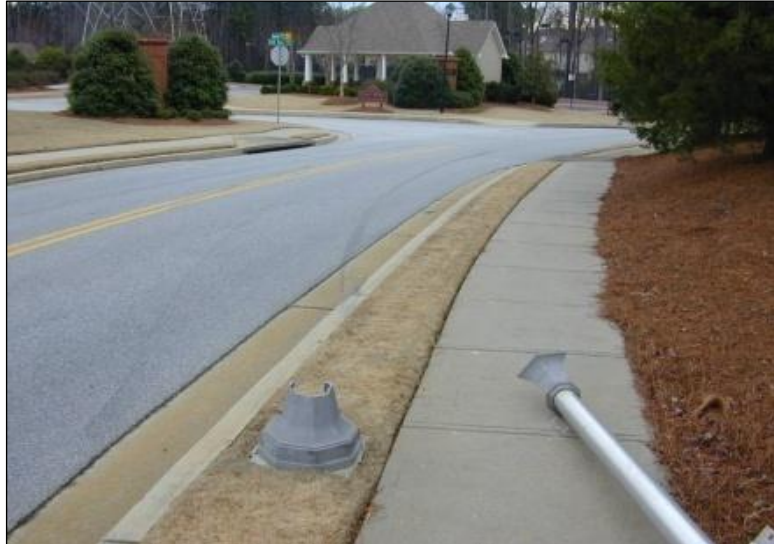
The City of Marietta Police investigated the incident. It was estimated that the vehicle was traveling approximately 40-50MPH in a 25 MPH zone when it crossed lanes and struck the radar sign.

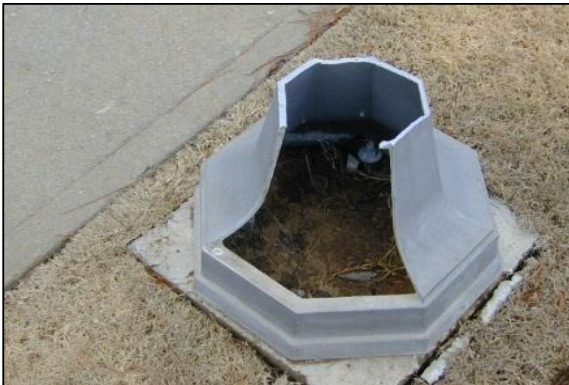
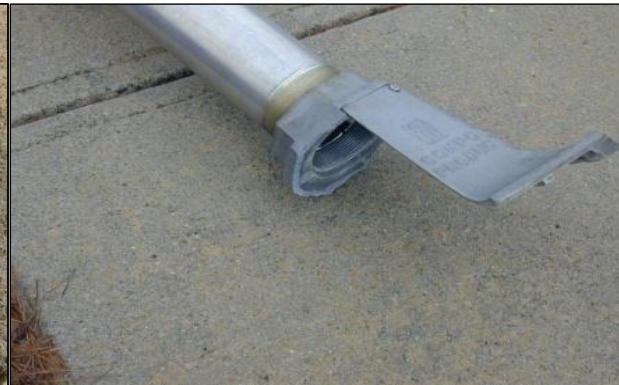
Radarsign's pole base broke away from the sign pole on impact as it was designed to do.

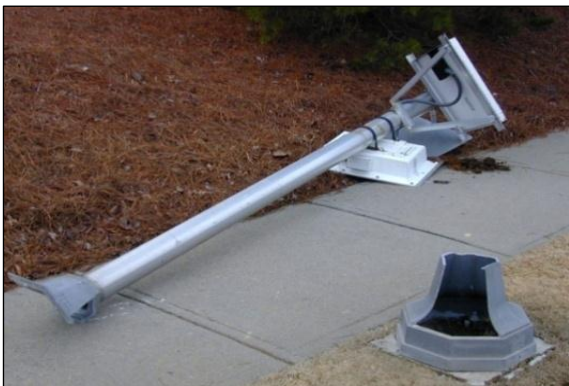
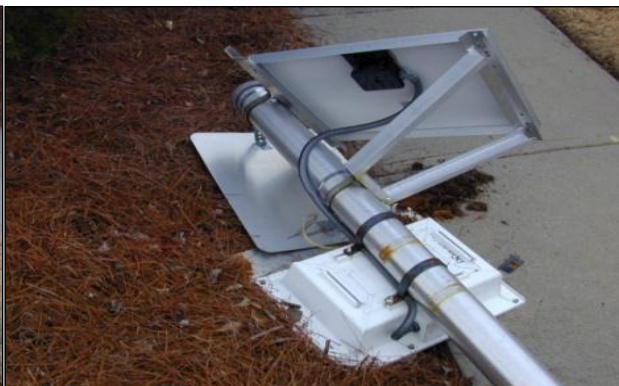
The radar sign sustained minimal cosmetic damage to the YOUR SPEED faceplate. The radar sign and solar panel remained operational and intact.
