Radarsign's Safety Compliant Breakaway Pole Base

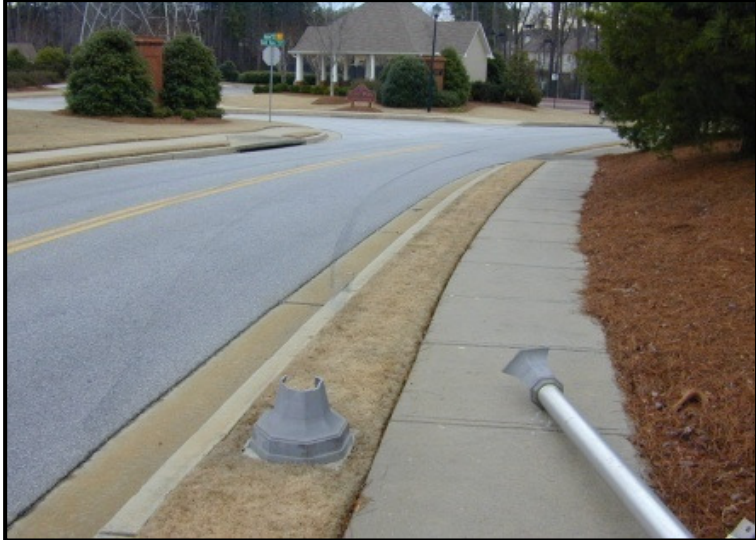
Radarsign in East Park subdivision in Marietta, GA prior to impact by a hit and run driver.

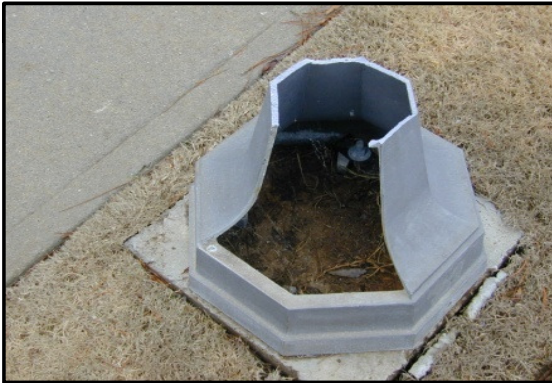
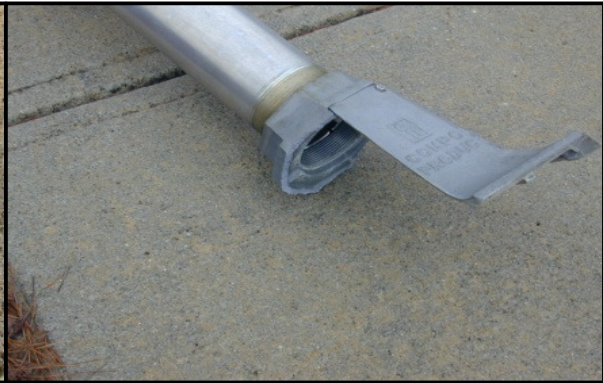
The City of Marietta Police investigated the incident. It was estimated that the vehicle was traveling approximately 40-50MPH in a 25 MPH zone when it crossed lanes and struck the radar sign.

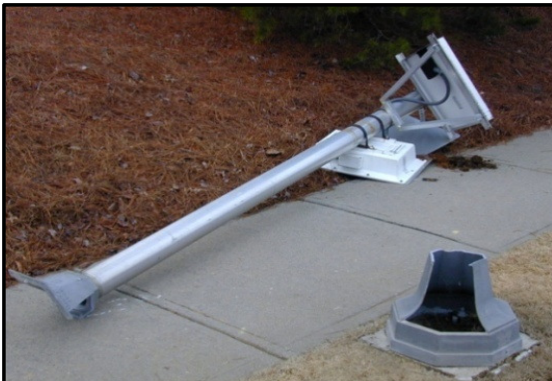
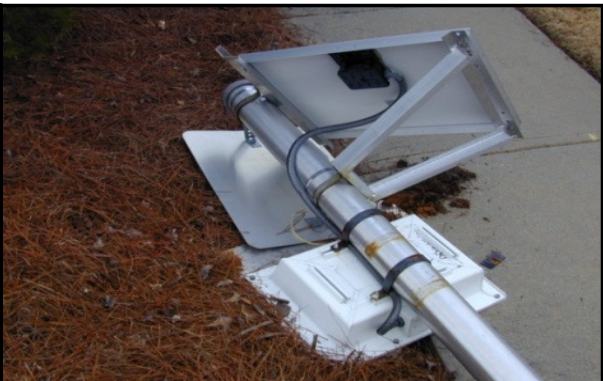
Radarsign's pole base broke away from the sign pole on impact as it was designed to do.

The radar sign sustained minimal cosmetic damage to the YOUR SPEED faceplate. The radar sign and solar panel remained operational and intact.
